Trelleborg
 Ruma

Objekat:
 Pumpa Demi voda 2

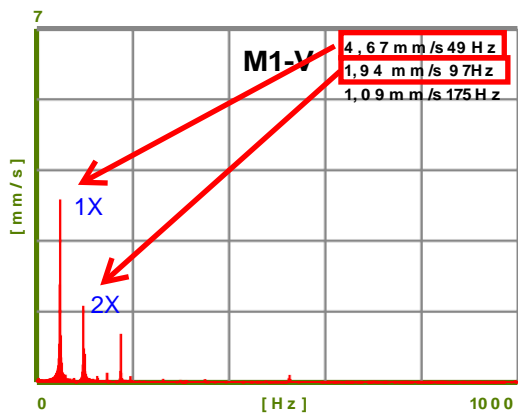
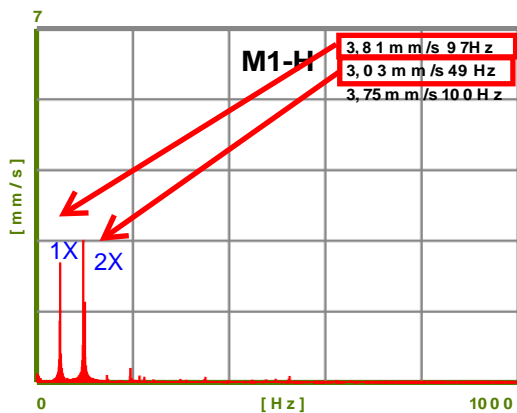
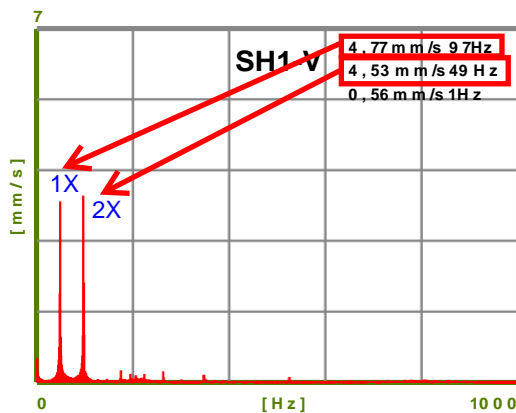
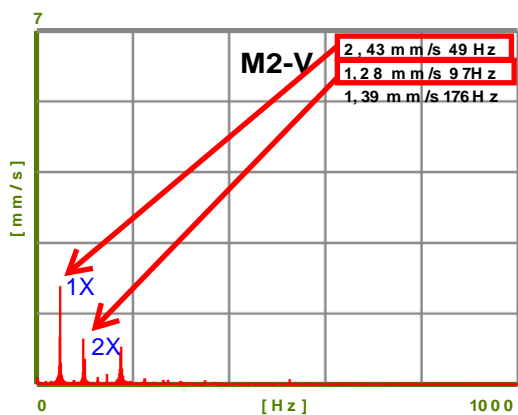
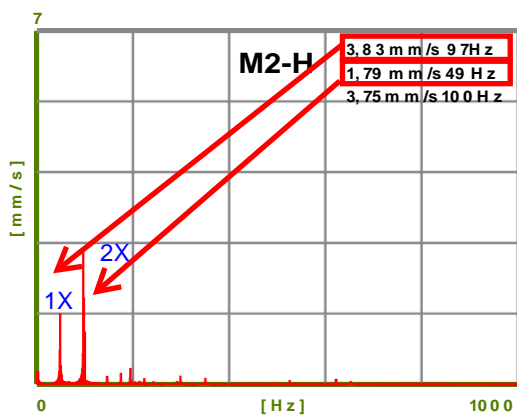
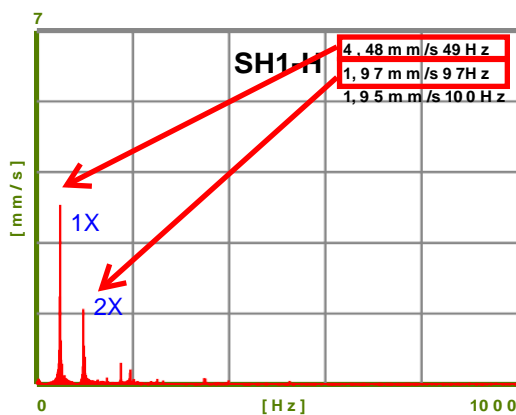
VIBRACIJE: Veff[mm/s] - Sel[%] - BNL [db]										
point	VERTICAL			HORIZONTAL			AXIAL			rpm
M1	5,32	0	23	5,08	0	26	1,39	0	17	0
M2	3,23	0	24	4,36	0	19	1,36	0	18	0
SH1	6,79	0	13	5,10	0	15				0
SH2	4,64	0	15	4,11	0	10				0
B1										
B2

Zaključak: Na osnovu FFT analize detektovan je izražen drugi pik koji upućuje na nesaosnost vratila pogonske i gonjene mašine. **Preporuka je dovesti vratila u saosnost.**
