Trelleborg
 Ruma

Objekat:
 Pumpa Demi voda 2

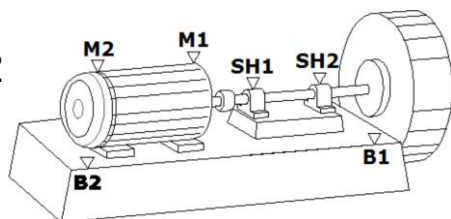
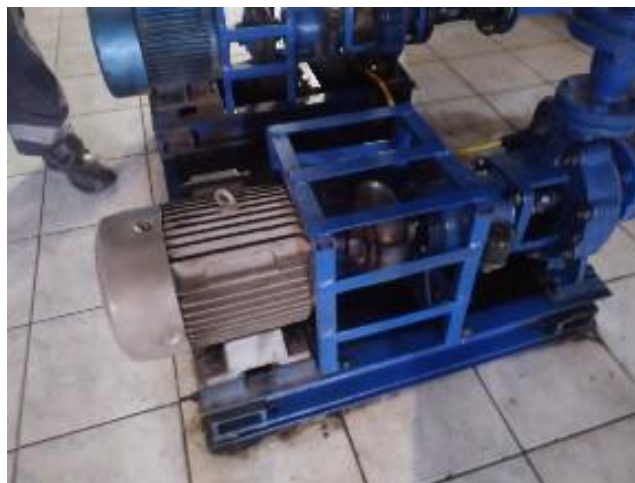
VIBRACIJE: Veff[mm/s] - Sel[%] - BNL [db]										
point	VERTICAL			HORIZONTAL			AXIAL			rpm
M1	5,32	0	23	5,08	0	26	1,39	0	17	0
M2	3,23	0	24	4,36	0	19	1,36	0	18	0
SH1	6,79	0	13	5,10	0	15				0
SH2	4,64	0	15	4,11	0	10				0
B1										
B2

Zaključak: Na osnovu FFT analize detektovan je izražen drugi pik koji upućuje na nesaosnost vratila pogonske i gonjene mašine. **Preporuka je dovesti vratila u saosnost.**
